GLENBRIDGE ENHANCEMENT PROJECT

*LOCATED IN BOARDMAN TOWNSHIP,
MAHONING COUNTY, OHIO*

MARCH 3, 2006

PROJECT SUMMARY

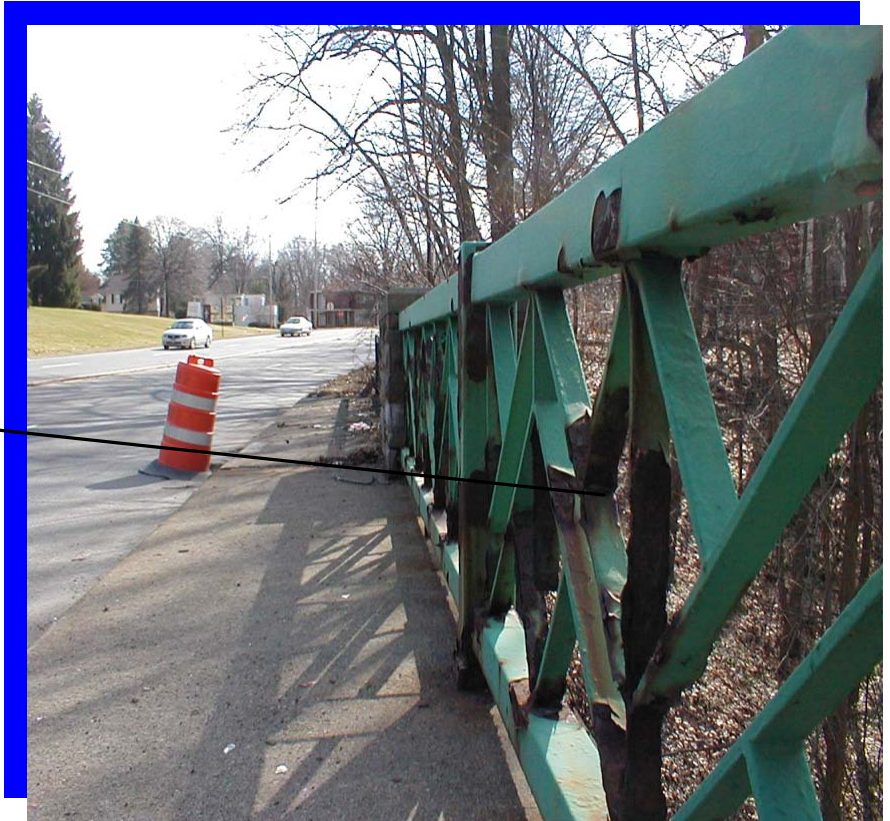
PHOTO IS OF THE WEST RAIL,
LOOKING SOUTH.

EXISTING RAIL IS SEVERELY
RUSTED AND CORRODED

- * Existing rail is an ornamental cross design mounted on vertical posts and tied to both the sidewalk decking and the sandstone faced parapet posts .
- * In keeping with the adjacent historic areas of “The Glen” and “Mill Creek Park”, we plan to replace this railing with a similar design as well as providing additional reinforcement to comply with today’s crash requirements.
- * We will extend the bridge designed rail into the approaches to eliminate the non-aesthetic sight of standard ribbon guardrail .

Replace existing steel panel sections on bridge with a black wrought iron rail.
Replace (and add) existing approach rail to bridge.

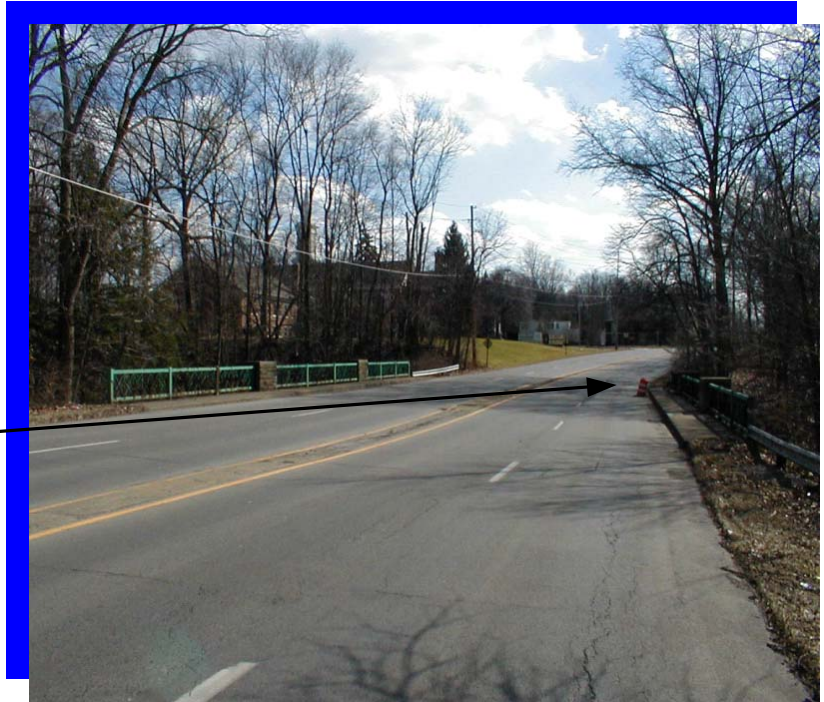
PHOTO IS GLENWOOD AVE.,
LOOKING SOUTH.

EXISTING ROADWAY DRAINAGE
SYSTEM IS FAILING.

- * Existing catch basins on the four (4) corners of the bridge need rebuilt .
- * Storm sewer line needs to added along the NE corner of the approach roadway to allow for sidewalk construction .
- * Other existing open ditches may need to be reshaped and /or redirected to catch basins with a new storm sewer .
- * Curb inlets may need to be added to improve overall roadway drainage .

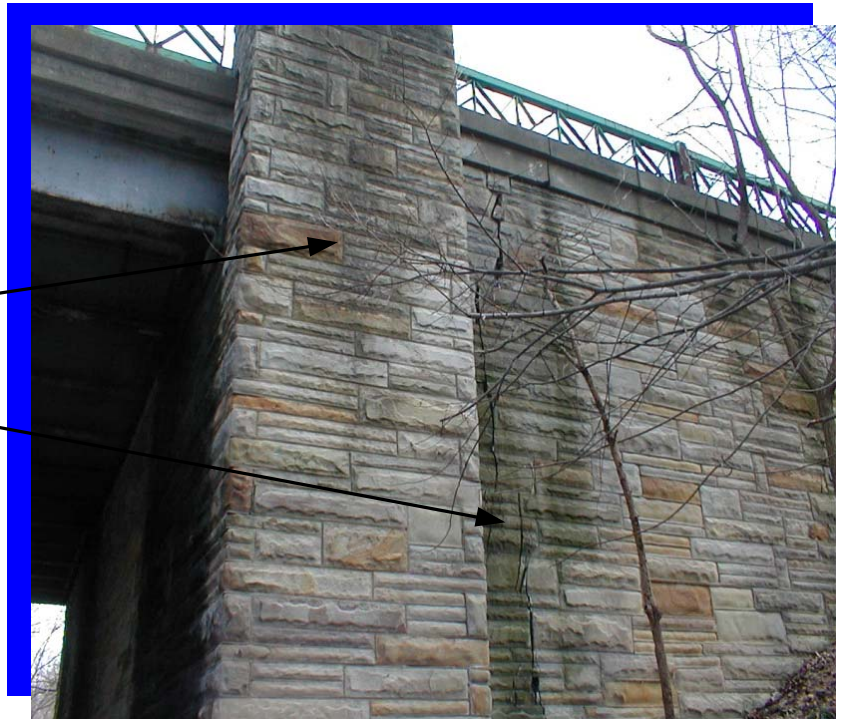
PHOTO IS FROM PARK DRIVE BELOW, LOOKING EAST AT SW CORNER OF BRIDGE

SANDSTONE FASCIA BRICK IS SEVERELY DISCOLORED.

VERTICAL CRACK IN WINGWALL IS EVIDENT ON ALL FOUR (4) CORNERS.

- * Sandstone fascia brick is deteriorating from water damage , all walls will be cleaned and sealed .
- * Cracks on walls have formed from a combination of expansion and water damage , cracks will be repaired and sealed . Sandstone fascia bricks will be replaced if needed .
- * Steel beams have significant paint loss , minor section loss near beam ends from water damage coming thru expansion and backwall . Beams will be cleaned and painted as per ODOT OZEU specifications .

Paint steel beams.
Repair cracks on bridge wingwalls.
Clean and seal sandstone fascia brick on abutments, wingwalls, and railing posts.

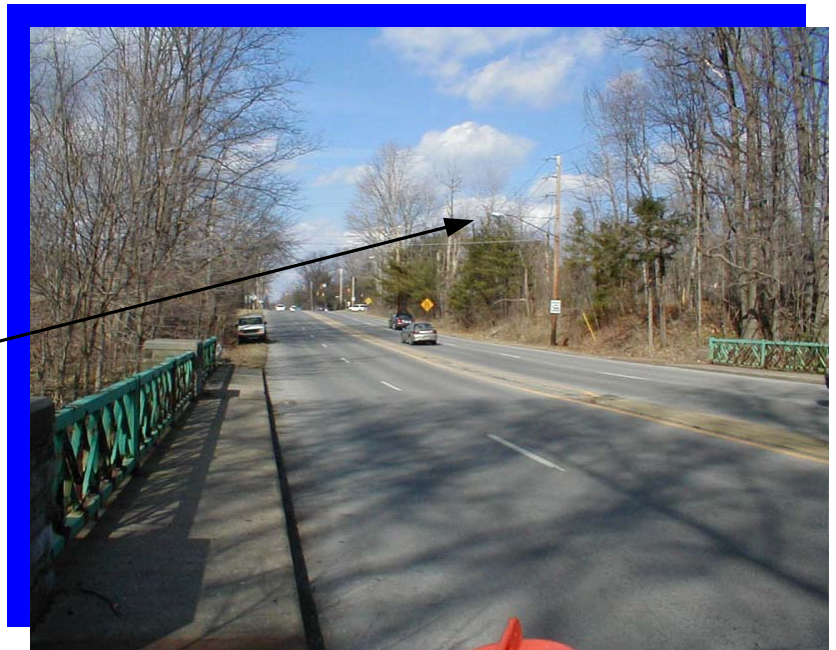
PHOTO IS LOOKING NORTH.

EXISTING HIGHWAY LIGHTING.

- * We intend to upgrade the existing highway lighting with high pressure sodium vapor lamps .
- * Four (4) lamp posts will be installed , one on each corner of the bridge . The posts will match the existing fixtures located in “The Glen” .

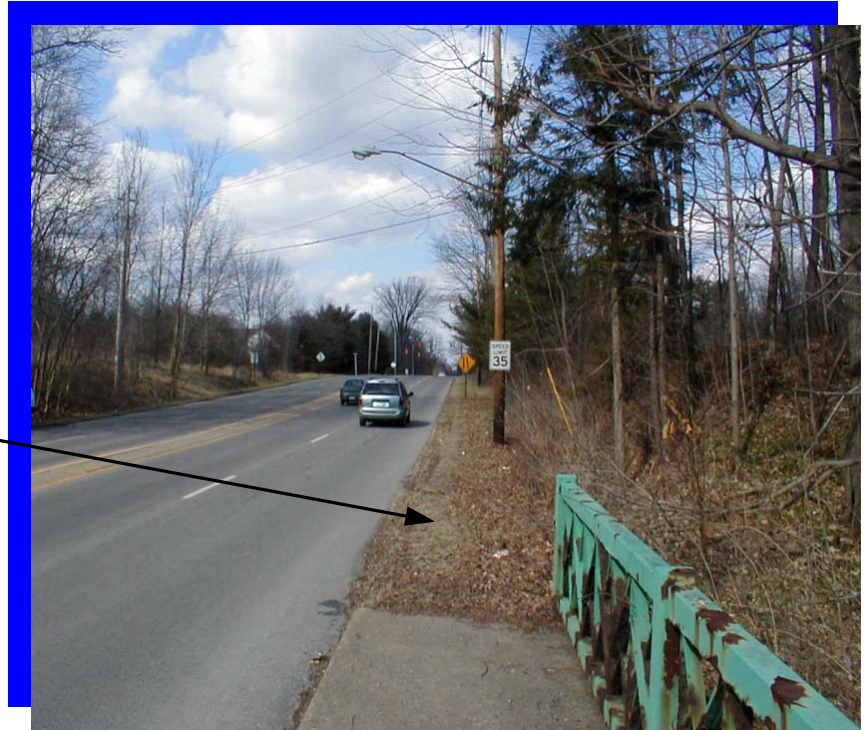
PHOTO IS LOOKING NORTH.

NO EXISTING SIDEWALKS ARE
LOCATED ALONG GLENWOOD AVE,
ON EITHER APPROACH TO THE BRIDGE

- * Proposed work includes constructing an entire sidewalk loop around Glenwood Ave ., Brookwood Ave ., and Mill Creek Drive
- * No sidewalk exists along Glenwood Ave . or Mill Creek Dr . Existing sidewalk along Brookwood Dr . will be replaced .
- * Also, the sidewalk termini on Overhill Dr . and Newport Dr . ends twenty (20') from the curblines . We intend to finish these walks to the curblines , thus tying into our proposed sidewalk extensions .
- * All walks will have handicap accessible ramps at the curb cuts .
